*Published in:*  
Water

# Mapping the Gap of Water and Erosion Control Measures in the Rapidly Urbanizing Mbezi River Catchment of Dar es Salaam

**Abstract:** In rapidly urbanizing catchments, increase in stormwater runoff may cause serious erosion and frequent floods if stormwater management systems are improper and dysfunctional. Through GIS-based modelling, field investigations, resident's questionnaire survey, and interviews with officials, the study set out to assess the coverage and efficiency of drainage infrastructure in Mbezi River catchment basin in Dar es Salaam, Tanzania. Between 2003 and 2016, the catchment imperviousness increased by 41%, causing flood incidents, massive erosion, and numerous pollution sources. Residents strive to address stormwater hazards using terraces, hedges, and physical barriers; however, the problems persist, indicating lack of coordination and poor causality understanding between land-use changes and catchment impacts. Small-scale stormwater harvesting was exercised by 75% of the households, pointing to water supply challenges. Municipal stormwater management efforts were limited to roadside drains covering 17% of road lengths in the catchm

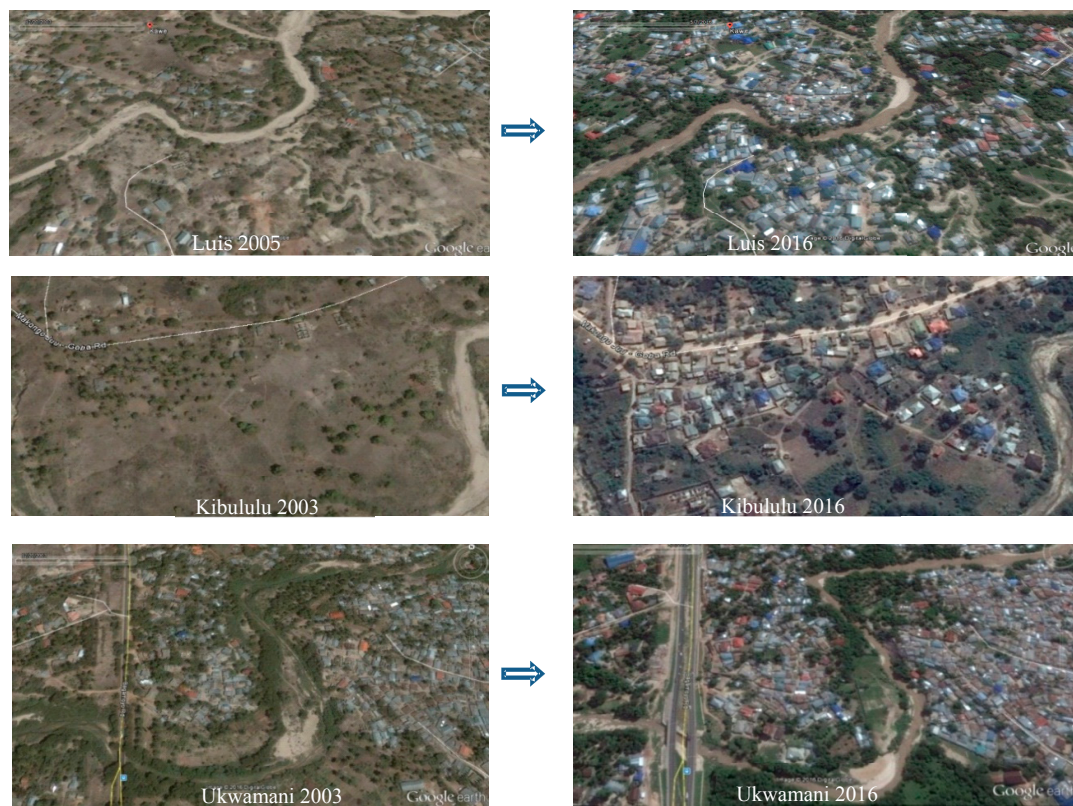
**Figure 4.** Urbanization trends from 2003 to 2016 in sub-case areas: Luis (**top row**); Kibululu (**middle row**); and Ukwamani (**bottom row**). Photos from: 2003 (**left column**); and 2016 (**right column**).

The results reveal an unfortunate matchup between catchment urbanization (Figures 3 and 4) and the evolution of stormwater related problems (Figure 2), indicating the need for change in management of the Mbezi River catchment area. If new stormwater management schemes are not adopted, it is likely that many of the assets in the already built-up areas will eventually be lost, since erosion gullies will multiply, and flooding events will become both more frequent and more intense. In addition, the freshwater supply is critical, as expressed by the many stormwater harvesting measures (Table 2). With rivers running dry and water being polluted by wastewater discharge and solid waste dumping (Figure 2), the residents are experiencing back-to-back problems with flood and erosion risks in the wet season and water scarcity in the dry season. Referring to studies done in other parts of the world, such problems require informed water resources planning and catchment-based urban stormwater management [43,44]. The goal of this study was to establish an empirical basis for implementing such new practices.

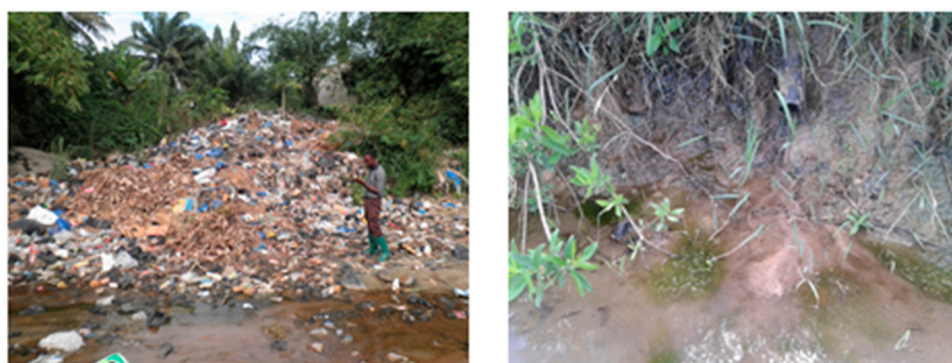
**Figure 5.** Solid and liquid waste dumping along Mbezi River. The photos were taken with permission on 24 June 2016.

Field observations revealed a number of direct discharges of polluted water as well as piles of solid waste blocking many natural drainage routes, as illustrated in Figure 5. Further, some drainage routes were levelled out for building projects (data not shown). Concerning erosion, this was especially widespread in the middle catchment area. In all cases, erosion was caused by runoff creating deeper and wider gullies as routes merged on their downstream routes. According to the questionnaire survey more than 45% of the respondents settled in riparian areas used the erosion gullies and eroded parts of the river for solid waste dumping, assuming it to be a solution to erosion problems on their land properties.
